INFORMATION REPORT

COUNTRY USSR (Moscow Oblast)

SUBJECT Rubber Factory and Research Station at Moscow

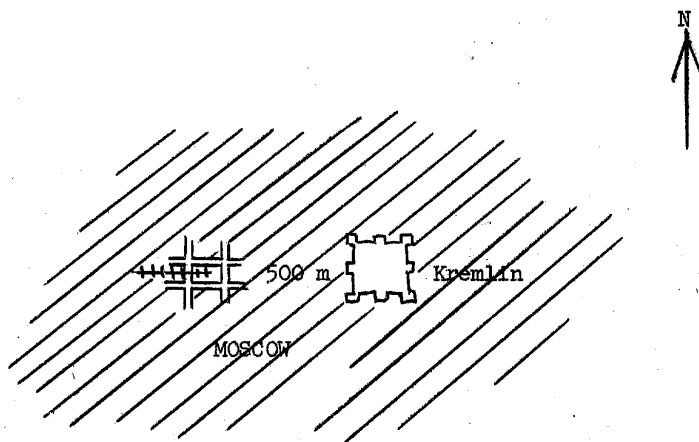
Sketch No. 1

1. A rubber factory and research station are situated about 500 meters west of the Kremlin (see sketch 1).¹

Location of Rubber Factory and Research Station at Moscow

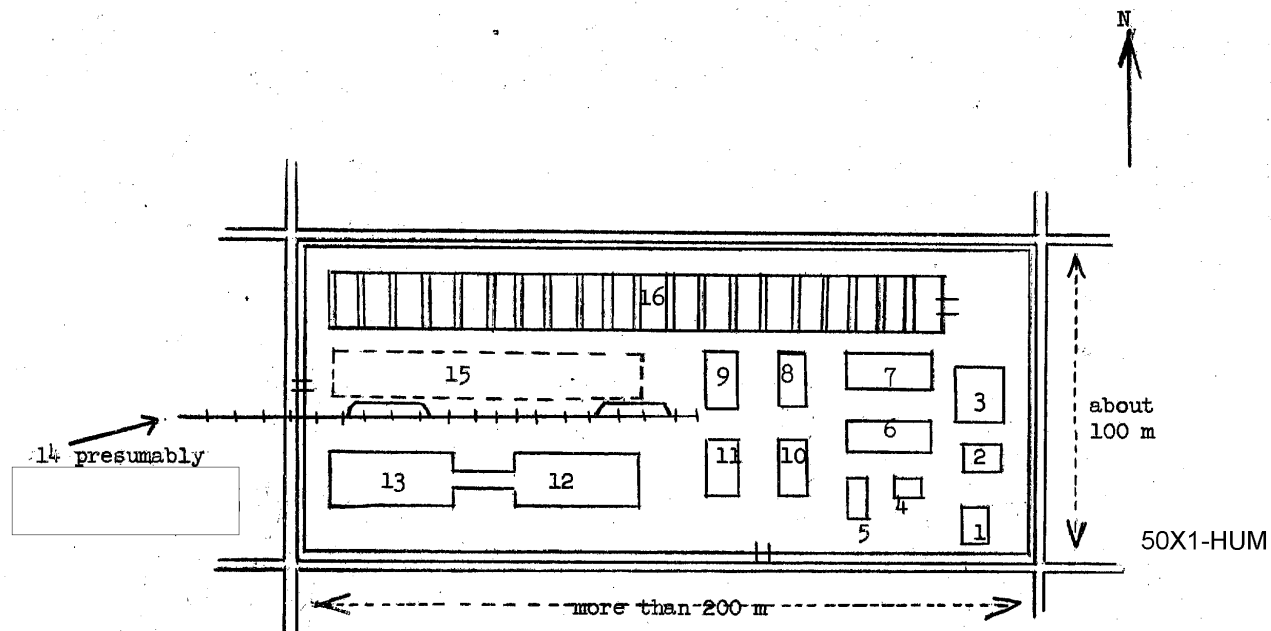
12. The factory site is quadrilateral in shape and covers an area of over 200 x 100 meters. The buildings are of brick and concrete. The key to Sketch No. 2 is as follows:

- 1) Two-story administration building.
 - 2) Two-story building. Soviet officials and German engineers occupy the upper story, and the ground floor is used as offices.

- 3) A solid single-story building.
 - 4), 5) Research laboratories.
 - 6), 7) Workshop about 30 meters in length. In one were tanks and aircraft wings which had been covered with rubber produced in the factory.

- 8), 9) Buildings resembling workshops about 20 meters in length.
 - 10), 11) Two-story buildings about 20 meters in length.
 - 12), 13) One-story buildings about 40 meters in length.

- 14) Russian gauge line with two ramps.
 - 15) An area about 100 meters in length on which are several sheds containing stores. Complete tanks, a few complete aircraft, also tank and aircraft components, especially wings, were accommodated in this area. 50X1-HUM
tanks of various sizes which were taken away after under- 50X1-HUM
going tests few complete aircraft but many aircraft wings of different sizes and construction.

- 16) A tall building of reinforced concrete containing a rifle range about 200 meters long and more than 20 meters wide. The roof was composed of sections of reinforced concrete arranged in such a way as to prevent bullets from leaving the building and at the same time admitting light. In this building tanks and aircraft which had been covered with rubber were fired on from different ranges by rifles and MGs. The wings of the aircraft came in for special attention. 50X1-HUM
noise of explosions coming from this building.

Plan of the Rubber Factory and Research Station at Moscow
